# DCS Home Inspections

## Oklahoma General Home Inspection Report

**Client(s): XXXXXXXXXXXXXXXX**  
**Property address: XXXXXXXXXXXX**  
**Owasso OK 74055-6944**  
**Inspection date: Tuesday, July 11, 2017**

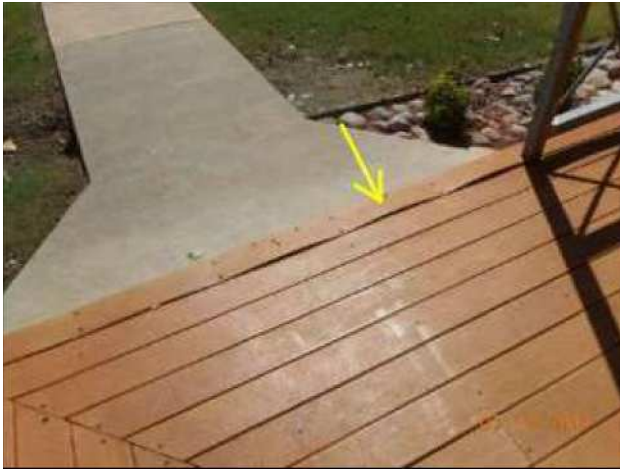
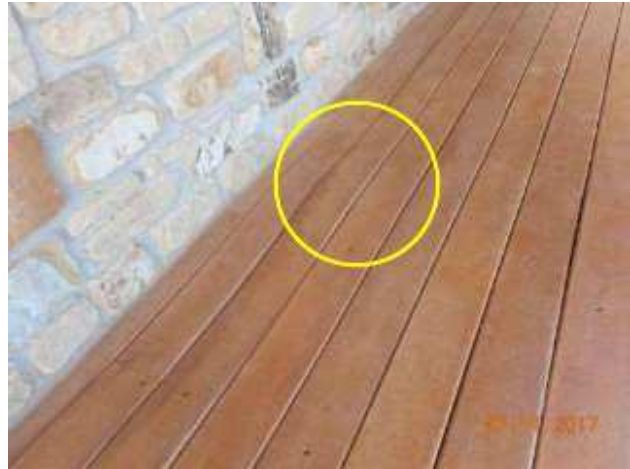
**1) Safety, Repair/Replace, Evaluate** - One or more trip hazards were found in deck sections due warping. A qualified contractor should evaluate and repair or replace deck sections as necessary to eliminate trip hazards and warped areas.

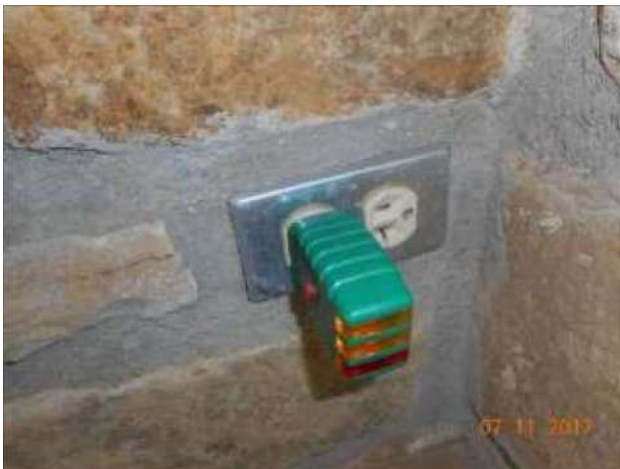
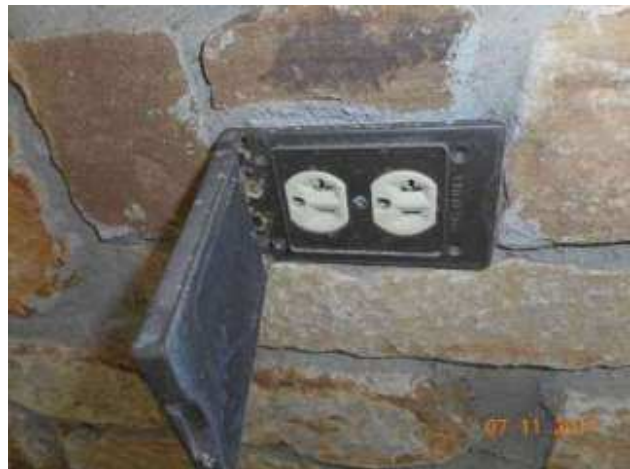
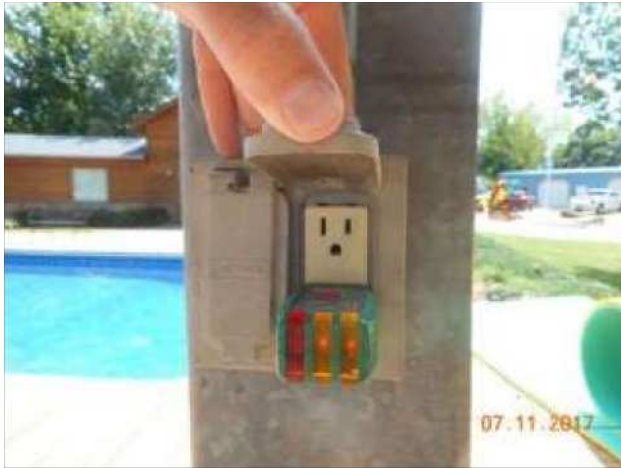
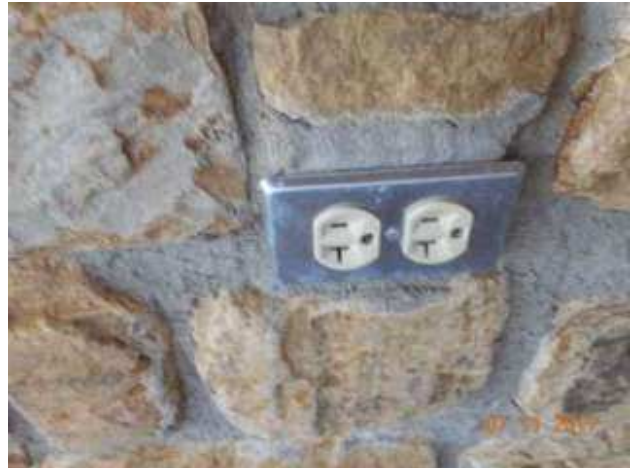
**2) Safety, Repair/Replace, Evaluate** - The outdoor electric receptacles appear to have no ground fault circuit interrupter (GFCI) protection. This is a safety hazard due to the risk of shock. A qualified electrician should evaluate to determine if GFCI protection exists, and if not, repairs should be made so that all outdoor receptacles have GFCI protection. For example, install GFCI receptacles or circuit breaker(s) as needed.

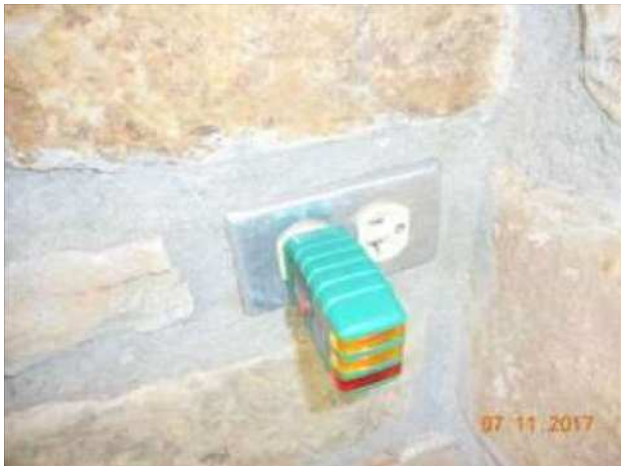
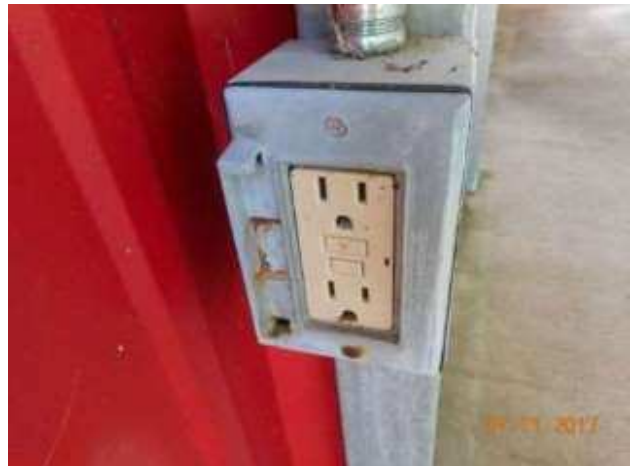
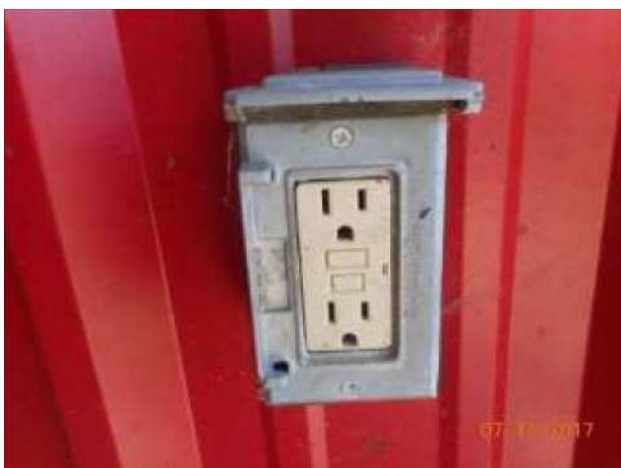
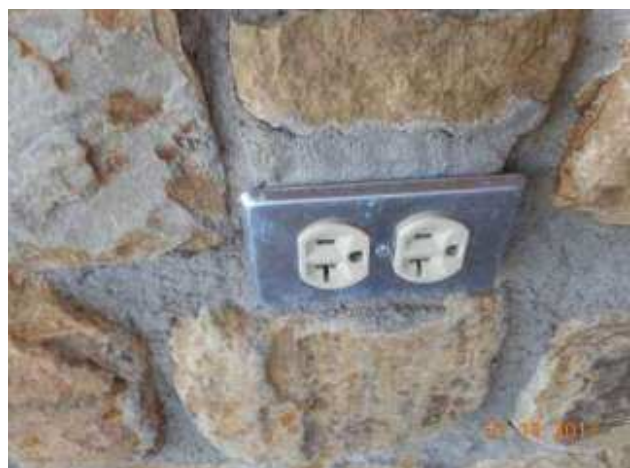
**3) Safety, Repair/Replace** - Waterproof cover(s) over several electric receptacles are damaged or missing. This is a safety hazard due to the risk of shock and fire. Damaged covers should be replaced where necessary.

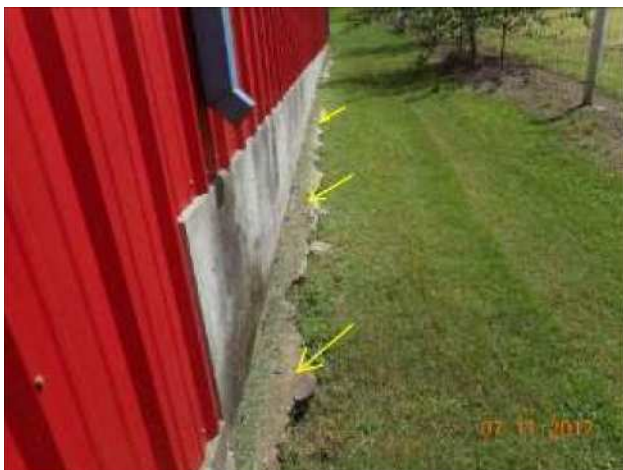
**Photo 4-1**

**4) Repair/Replace** - At the back of the shop one section of foundation footings are above grade. Footings should be below grade so adequate lateral support is

provided by the soil. Soil should be installed as necessary so footings are below grade.

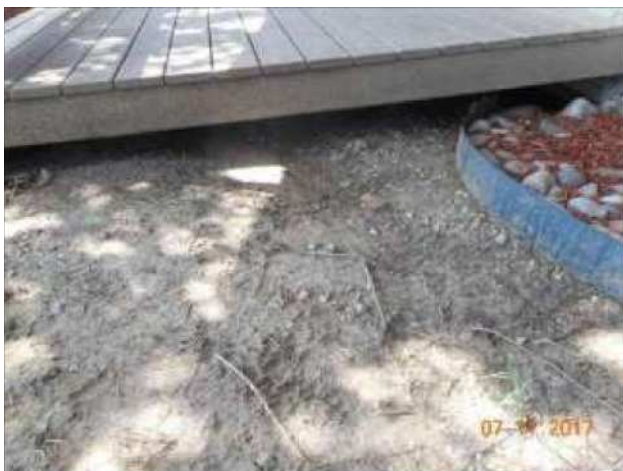
**Photo 5-1**

**5) Repair/Replace** - Low soil areas on the perimeter grading were found at the front of the guest house. This can result in water accumulating around the structure's foundation. Accumulated water is a conducive condition to wood destroying insects and organisms. Wet soil may also cause the foundation to settle over time. Recommend grading soil so it slopes down and away from the structure with a slope of at least 5% (10% or better is optimal) for at least 6 feet.

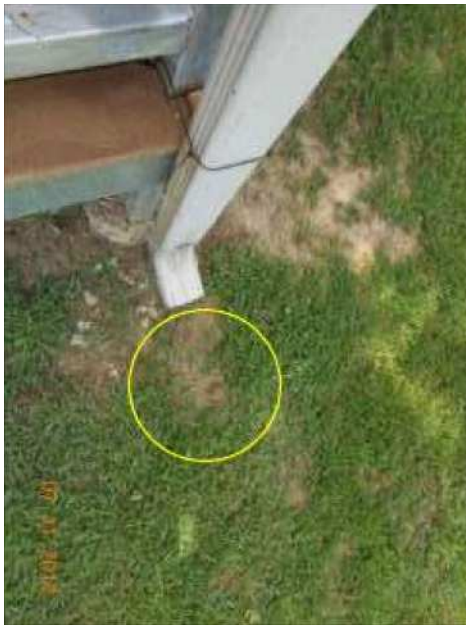
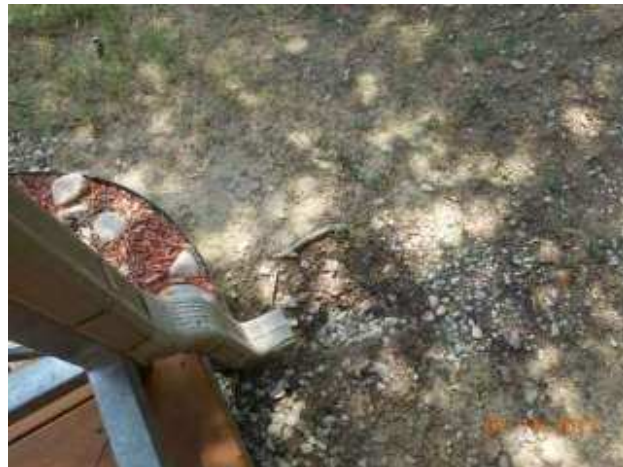
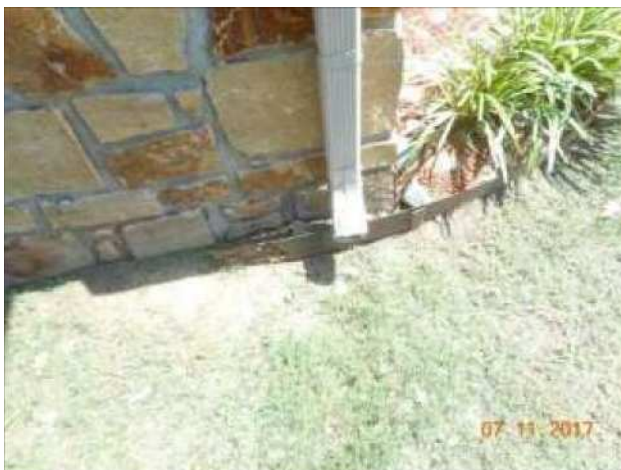
**6) Minor Defect** - Several downspouts have no extensions. This can result in water accumulating around the structure's foundation. Accumulated water is a conducive condition to wood destroying insects and organisms, and may also cause the foundation to settle over time. Repairs should be made as necessary, such as installing splash blocks so rain water is carried at least several feet away from the structure to soil that slopes down and away from the structure.

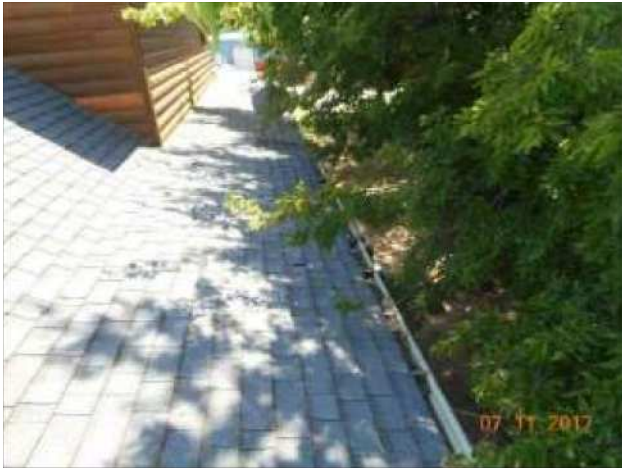
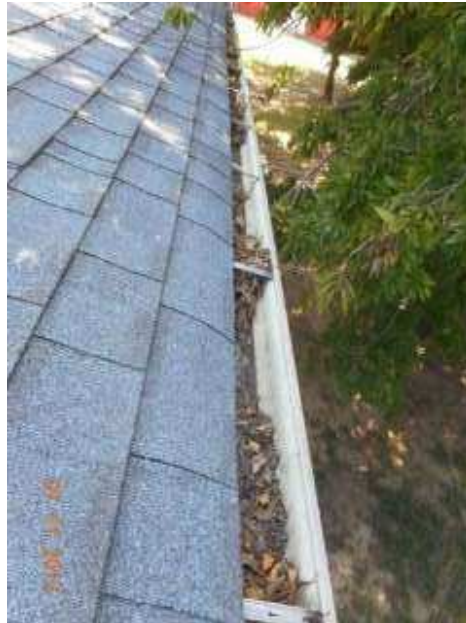
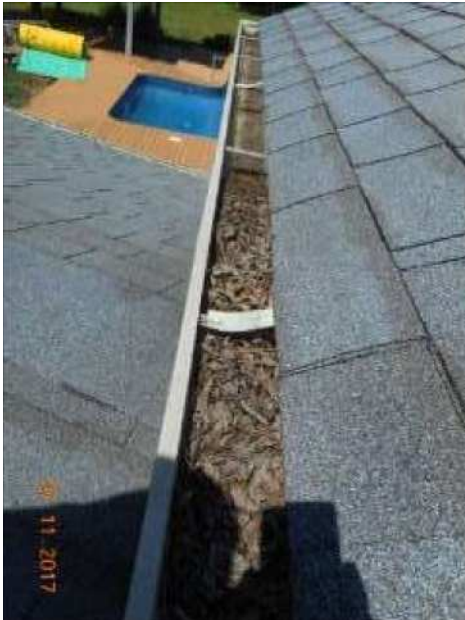
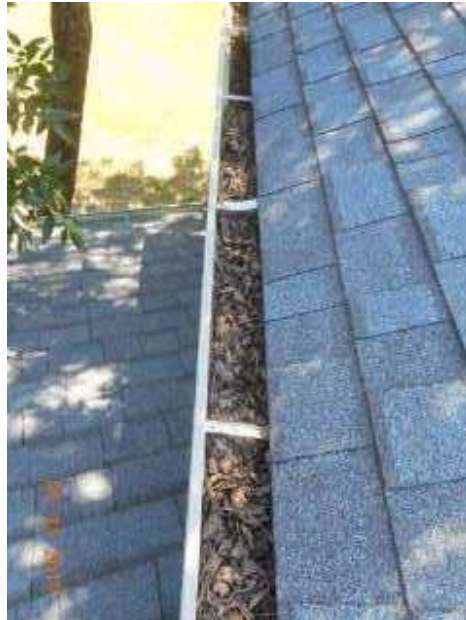
**7) *Minor Defect*** - The gutters are full of debris. Clean gutters as needed.  
( Both homes.)

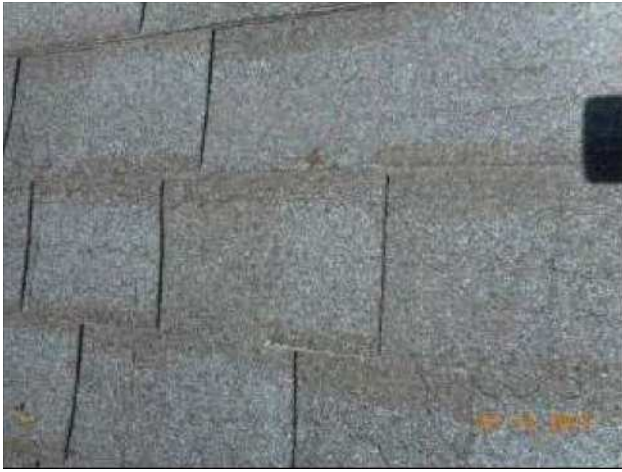
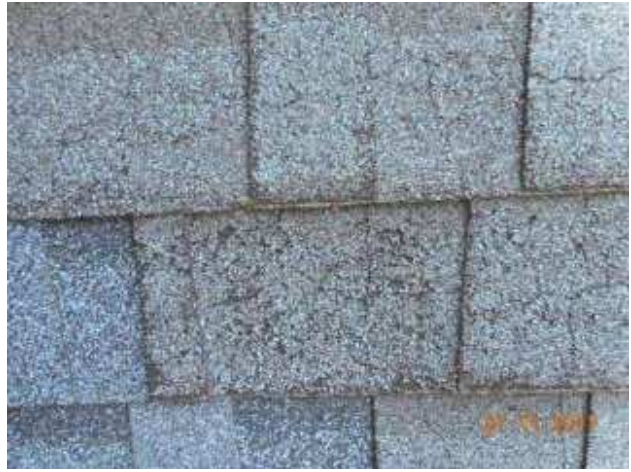
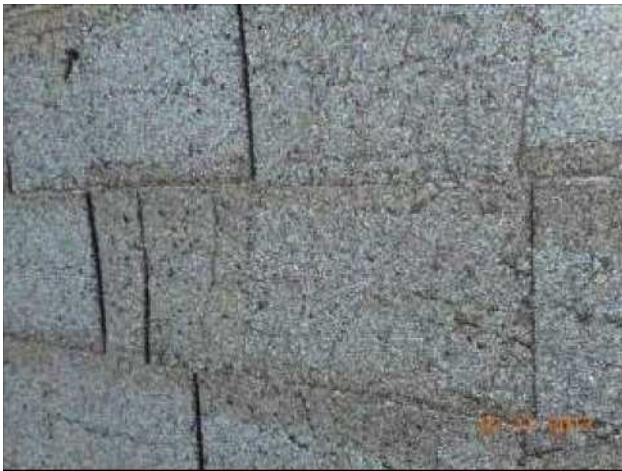
**8) Repair/Replace, Evaluate** - The main house roof surface material appears to be near the end of its service life. The client(s) should consult with an insurance agent to determine the coverage available. If the coverage is not adequate client should consult with a qualified roofing contractor to determine

repair or replacement options and costs. Proper ventilation should be provided with a new roof, 3-4 box vents or a ridge vent is recommended. All rubber boot flashings should be replaced. Drip edge flashing is also recommended to prevent water from wicking under the siding.

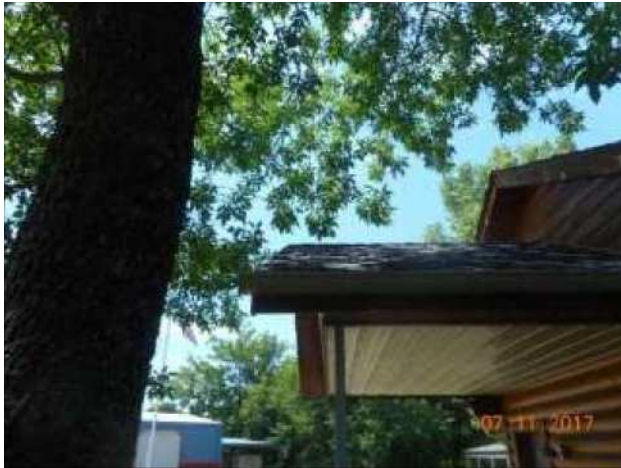
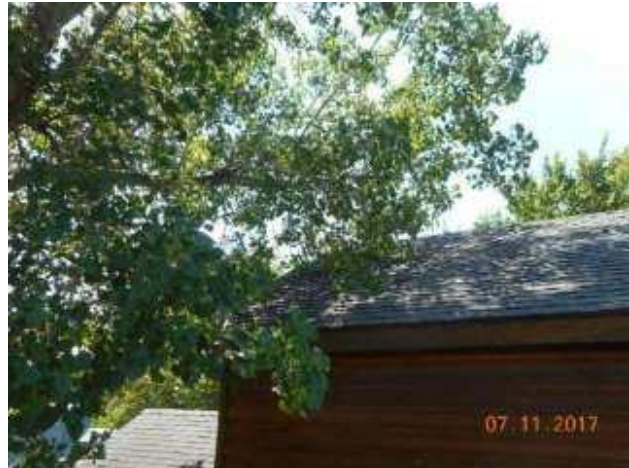
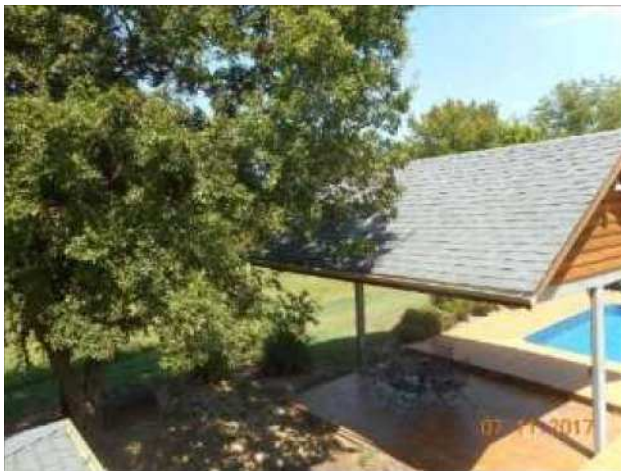
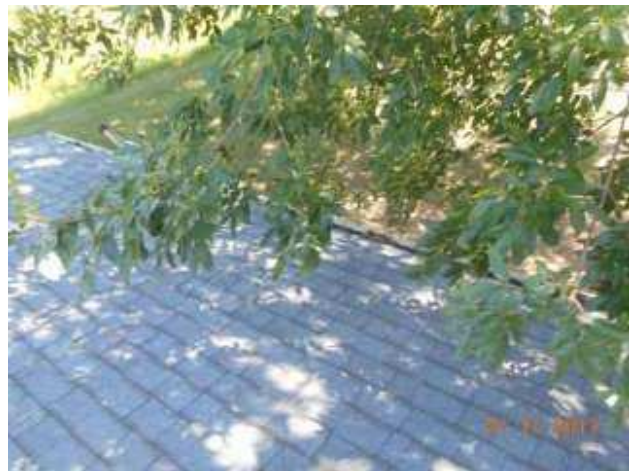
**9) Maintain** - Trees are in contact with or are close to the roof edge(s) in one or more areas. Damage to the roof may result, especially during high winds. Vegetation can also act as a conduit for wood destroying insects. Vegetation should be pruned back and/or removed as necessary to prevent damage and infestation by wood destroying insects. ( Both houses and pool area.)

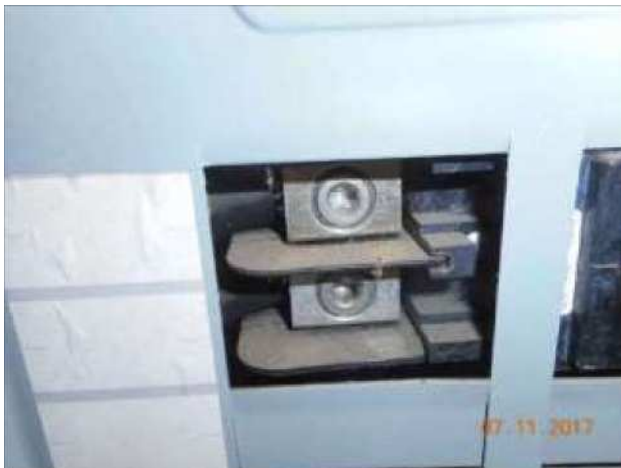
**Photo 12-1**

**12) Safety, Minor Defect** - One knockout has been removed inside the shop main service panel where no wires and bushings are installed, and no cover(s) have been installed to seal the hole(s). This is a safety hazard due to the risk of fire. A qualified electrician should install knockout covers where missing.

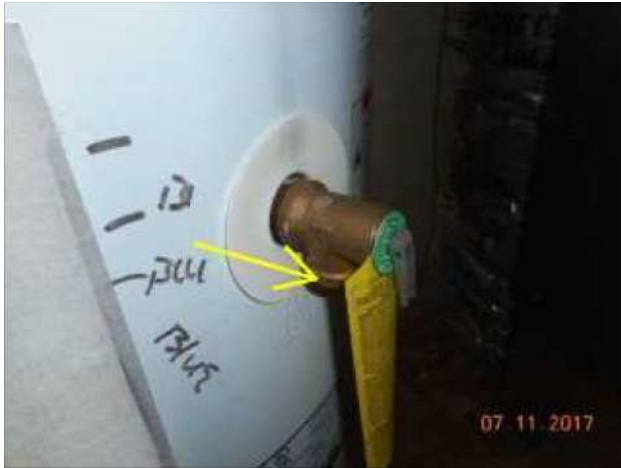
**Photo 13-1**

**13) Safety, Repair/Replace** - No drain line is installed for the temperature-pressure relief valve. This is a potential safety hazard due to the risk of scalding if someone is standing next to the water heater when the valve opens. A qualified plumber should install a drain line as per standard building practices. For example, extending to 6 inches from the floor, or routed so as to drain outside.

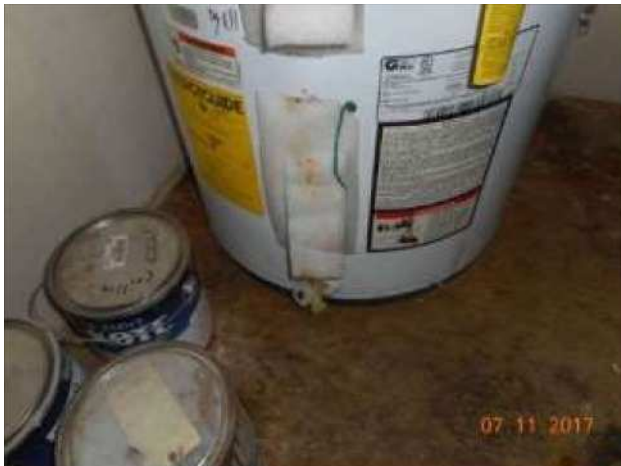
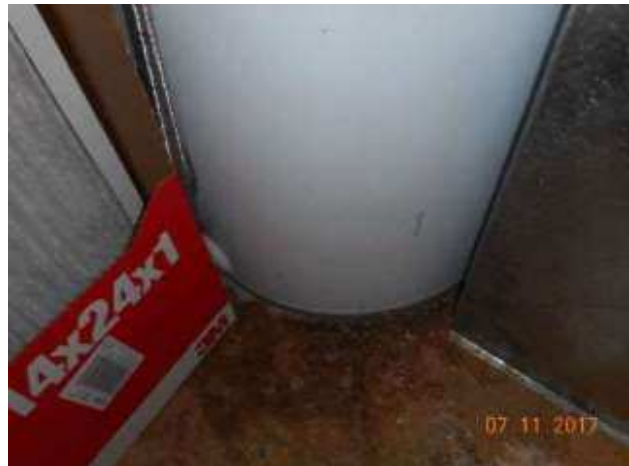
**14) Repair/Replace, Evaluate** - Both water heaters are installed over finished living spaces and has no catch pan and drain installed. Recommend having a qualified contractor install a catch pan and drain to prevent water damage to finished interior spaces below if/when the water heater develops a leak or is drained.

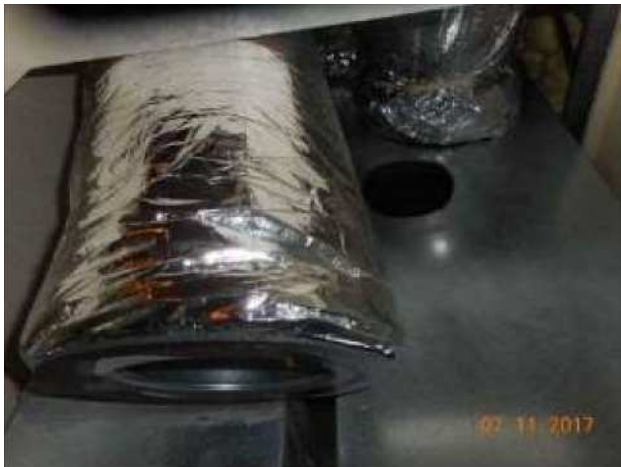
**Photo 15-1**

**15) Repair/Replace, Evaluate** - One or more air supply ducts are broken or disconnected. Increased moisture levels in unconditioned spaces and higher energy costs may result. A qualified contractor should evaluate and make permanent repairs as necessary. ( No air flow upstairs.)

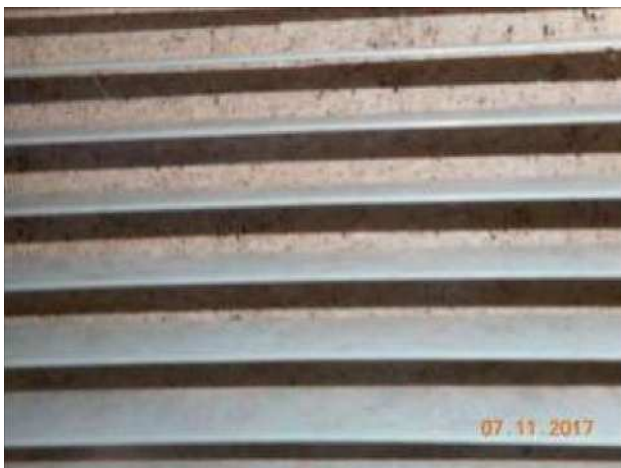
**Photo 16-1**

**16) Repair/Maintain, Evaluate** - The cooling fins on the two ton outdoor condensing unit's evaporator coils are dirty. This may result in reduced efficiency and higher energy costs. A qualified heating and cooling contractor should clean the coils as necessary.

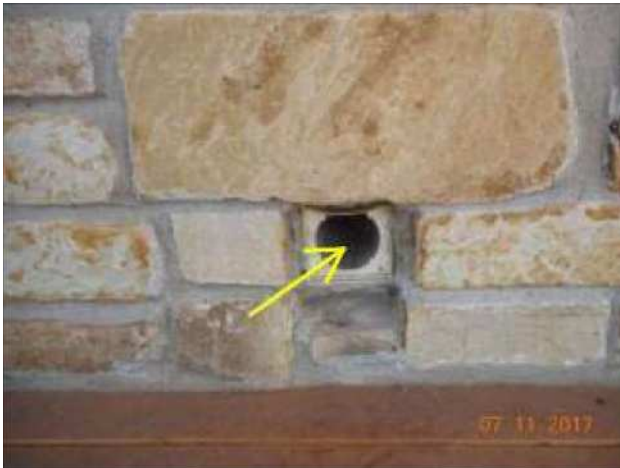
**Photo 17-1**

**17) Safety, Minor Defect** - The clothes dryer vent cover is missing. The vent cover should be replaced to prevent insect intrusion that could lead to fires.

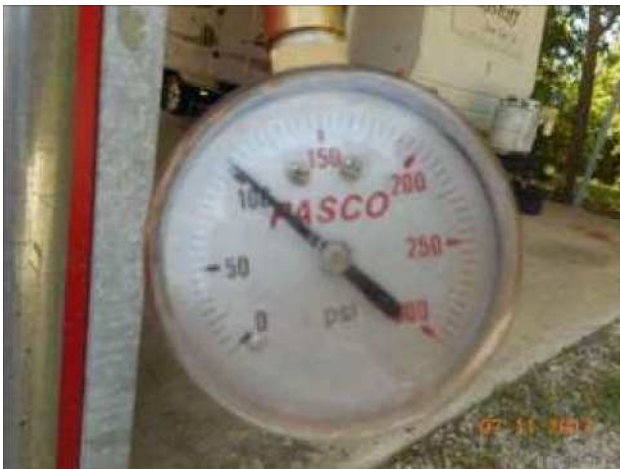
**Photo 18-1**

**18) Repair/Replace, Evaluate** - The water supply pressure is greater than 80 psi ( 105 psi ). Pressures above 80 psi may void warranties for some appliances such as water heaters or washing machines. Flexible supply lines to washing machines are more likely to burst with higher pressures. Typically the pressure cannot be regulated at the water meter. Recommend having a qualified plumber evaluate and make modifications to reduce the pressure below 80 psi. Installing a pressure reducing valve on the main service pipe is a common solution to this problem. If one exists, then it should be adjusted for lower pressures.

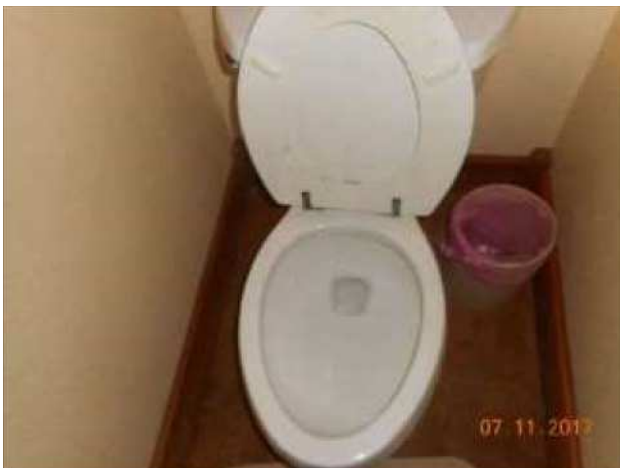
**Photo 23-1**

**23) Repair/Replace, Evaluate** - The half bathroom toilet "runs" after being flushed, where water leaks from the tank into the bowl. Significant amounts of water can be lost through such leaks. A qualified plumber should evaluate and repair or replace components as necessary.

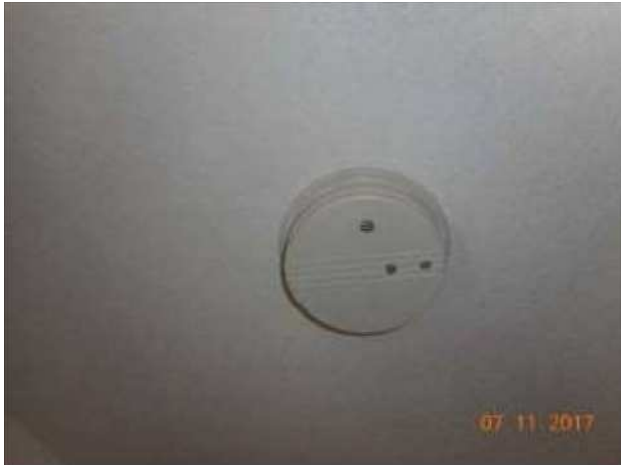
**Photo 24-1**

**24) Safety, Repair/Replace** - The front bedroom smoke alarms did not test with the test buttons. Smoke alarms should be replaced as necessary. For more information, visit <http://www.cpsc.gov/cpscpub/pubs/5077.html>

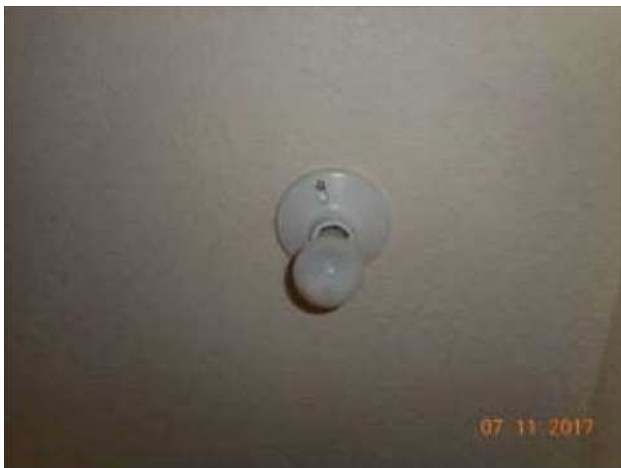
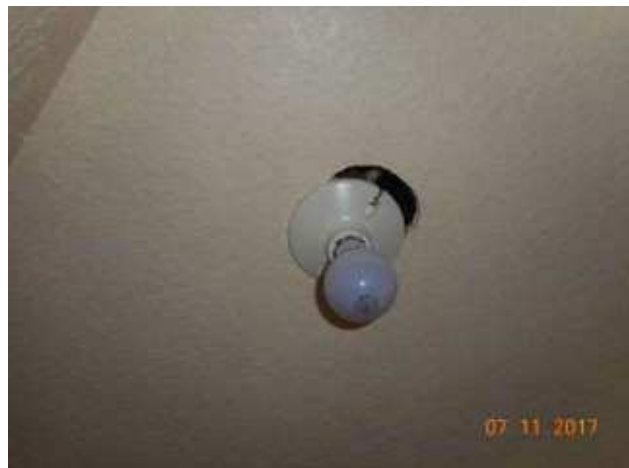
**25) Safety, Repair/Replace** - Lamp holders or light fixtures with fully exposed bulbs are installed in several bedroom closets. This is a safety hazard. Standard building practices require closet lighting to use fully enclosed incandescent fixtures. A qualified electrician should replace closet lights as necessary and as per standard building practices.

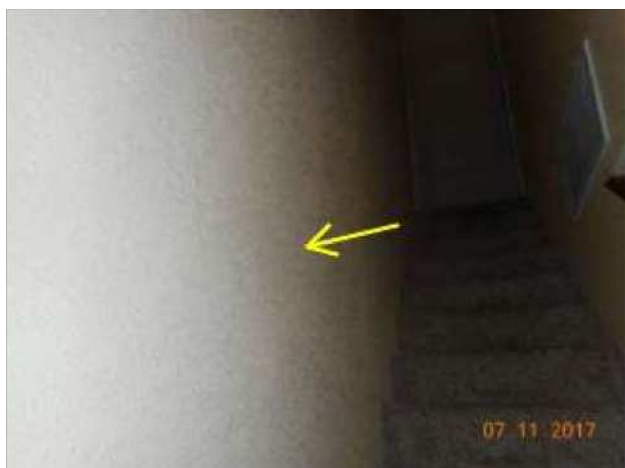
**Photo 26-1**

**26) Safety, Repair/Replace** - One flight of stairs with more than two risers has no handrail installed. This is a safety hazard. A qualified contractor should install graspable handrails that your hand can completely encircle at stairs where missing, and as per standard building practices.

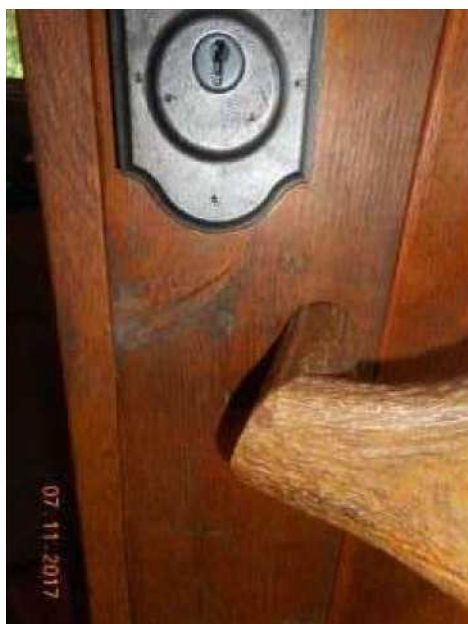
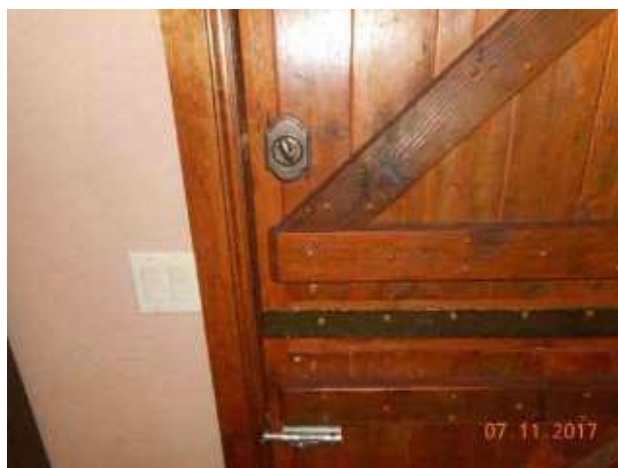
**27) Repair/Replace** - Both doors have no lockset installed. Locksets should be installed where missing.

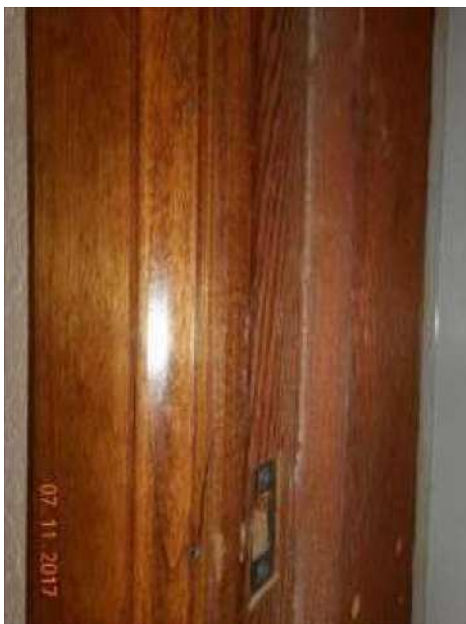
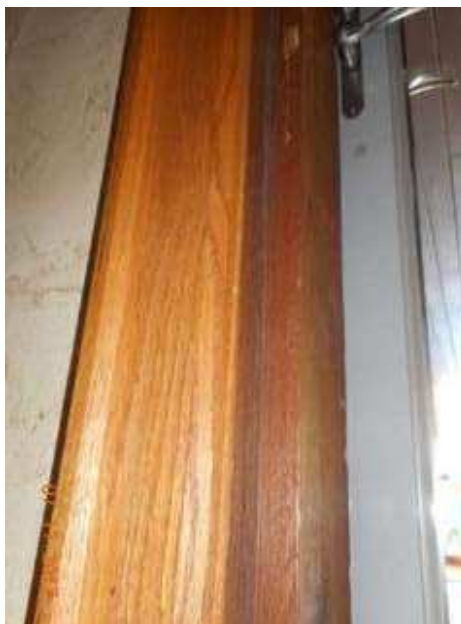
**28) Repair/Replace** - The weatherstrip around the front and back doors is missing. Weatherstrip should be installed where missing.
